# The Upper Mississippi Valley Lead-Zinc District Revisited: Mining History, Geology, Reclamation, and Environmental Issues Thirty Years after the Last Mine Closed

Guidebook for the 2009 Meeting  
of the North-Central Section  
of the Geological Society of America

Guidebook 38 2009

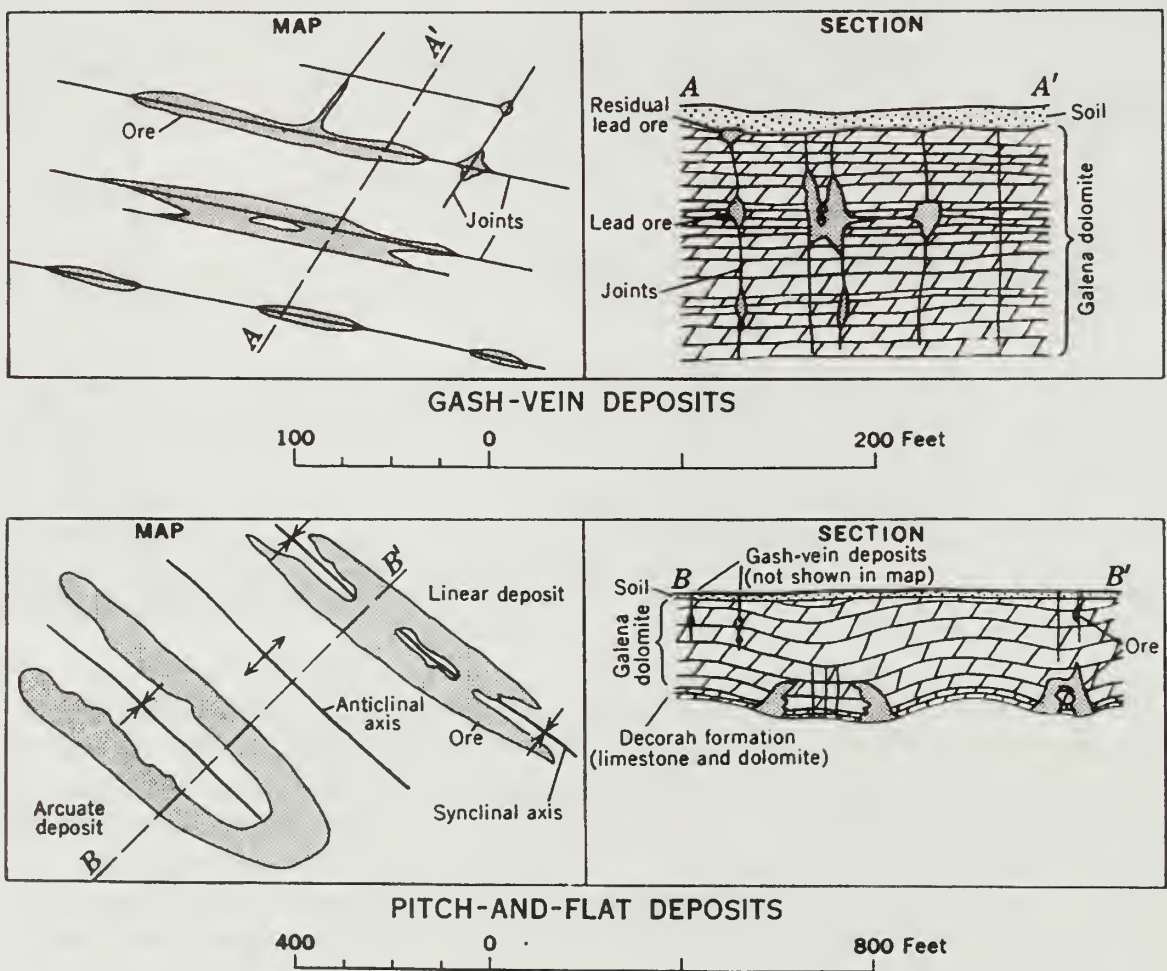
**Figure 3** Diagrammatic plan and section views illustrating typical gash-vein lead deposits and underlying pitch-and-flat zinc-lead deposits (after Heyl et al. 1970).

Zinc ore, primarily sphalerite and minor amounts of smithsonite, was found below the lead veins and was concentrated in the pitch-and-flat deposits in which the shaly Decorah carbonates were dissolved and replaced by sphalerite, pyrite, and marcasite, along with calcite and/or barite as gangue minerals (Figure 3). The pitches were dipping fractures in the Galena carbonates, formed above the flat deposits, resulting from subsidence caused by dissolution of the Decorah. The pitches were commonly mineralized. The zinc deposits were deeper than the lead veins and required larger-scale mining operations, including high-capacity pumps for dewatering.

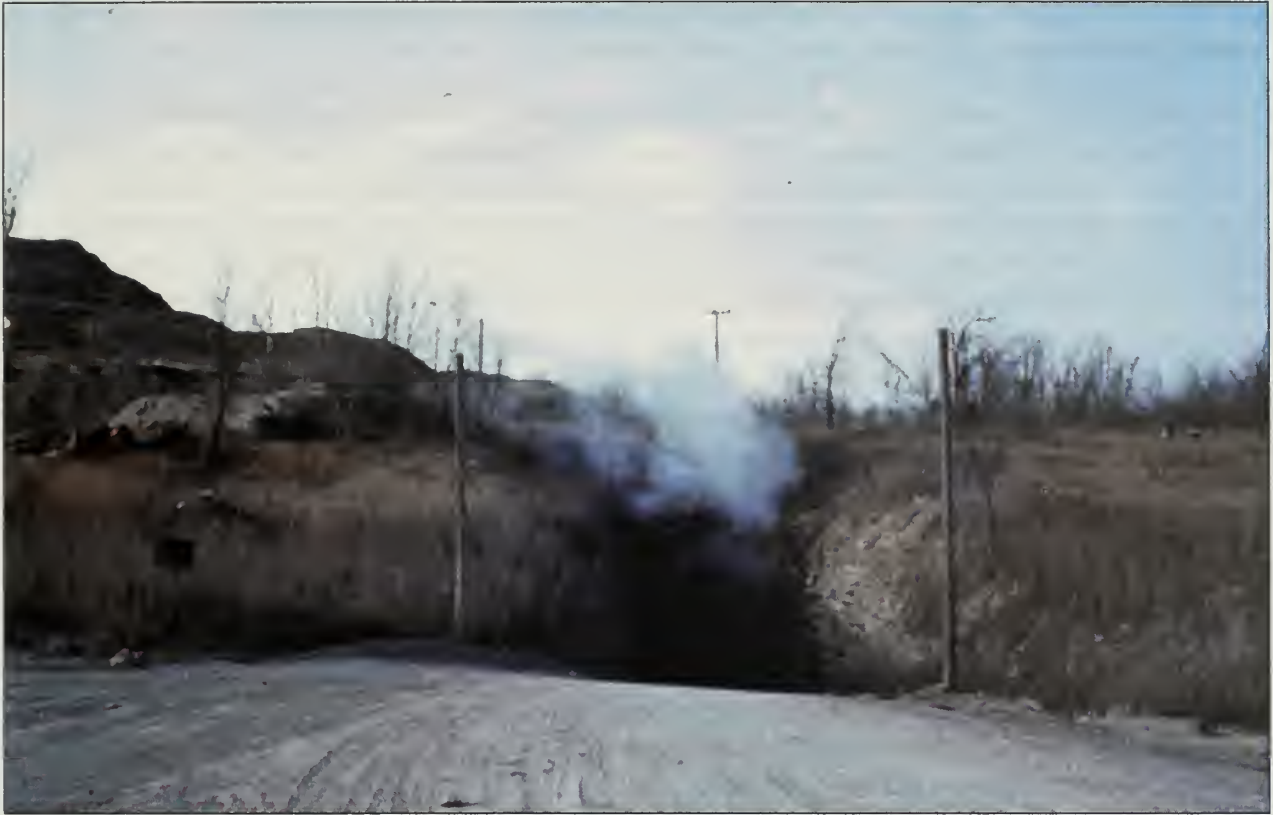
**Figure 4** *Inclined shaft portal at the Shullsburg mine (circa 1970s). Similar truck access declines replaced vertical shafts during the later years of mining.*

Eagle-Picher operated the Shullsburg mine and mill continuously from 1954 until 1979. The zinc and lead ore was originally hoisted through a two-compartment shaft, but later a decline was constructed so that trucks could haul the ore to the surface, and equipment could be driven directly to the working face. Eagle-Picher extracted about 1,000 tons of ore per day using a modified room-and-pillar mining method and processed about 1,500 tons of ore per day in the flotation mill. The additional ore was hauled by truck from the nearby Bear Hole mine for processing at the mill.

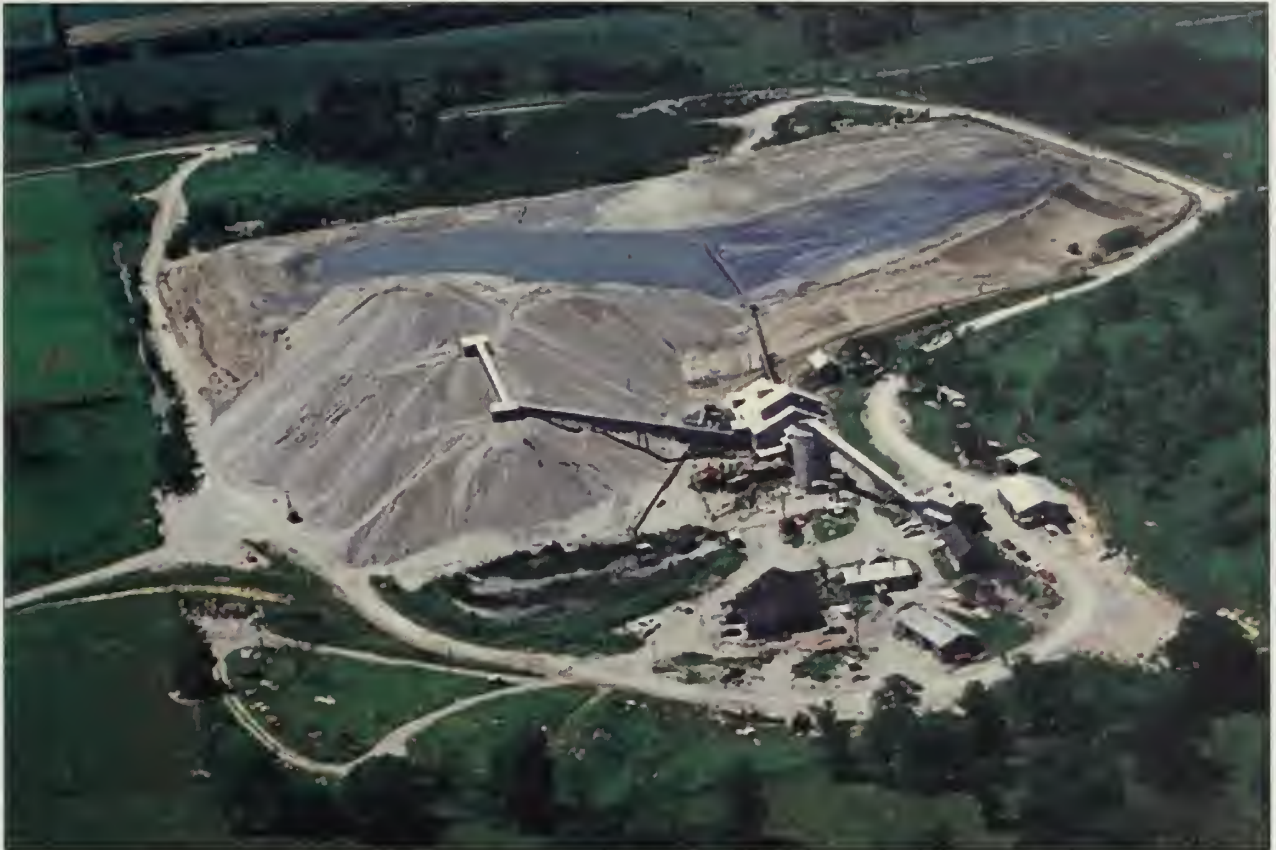
**Figure 5** Overview of the Shullsburg mine and flotation mill site circa 1970s.

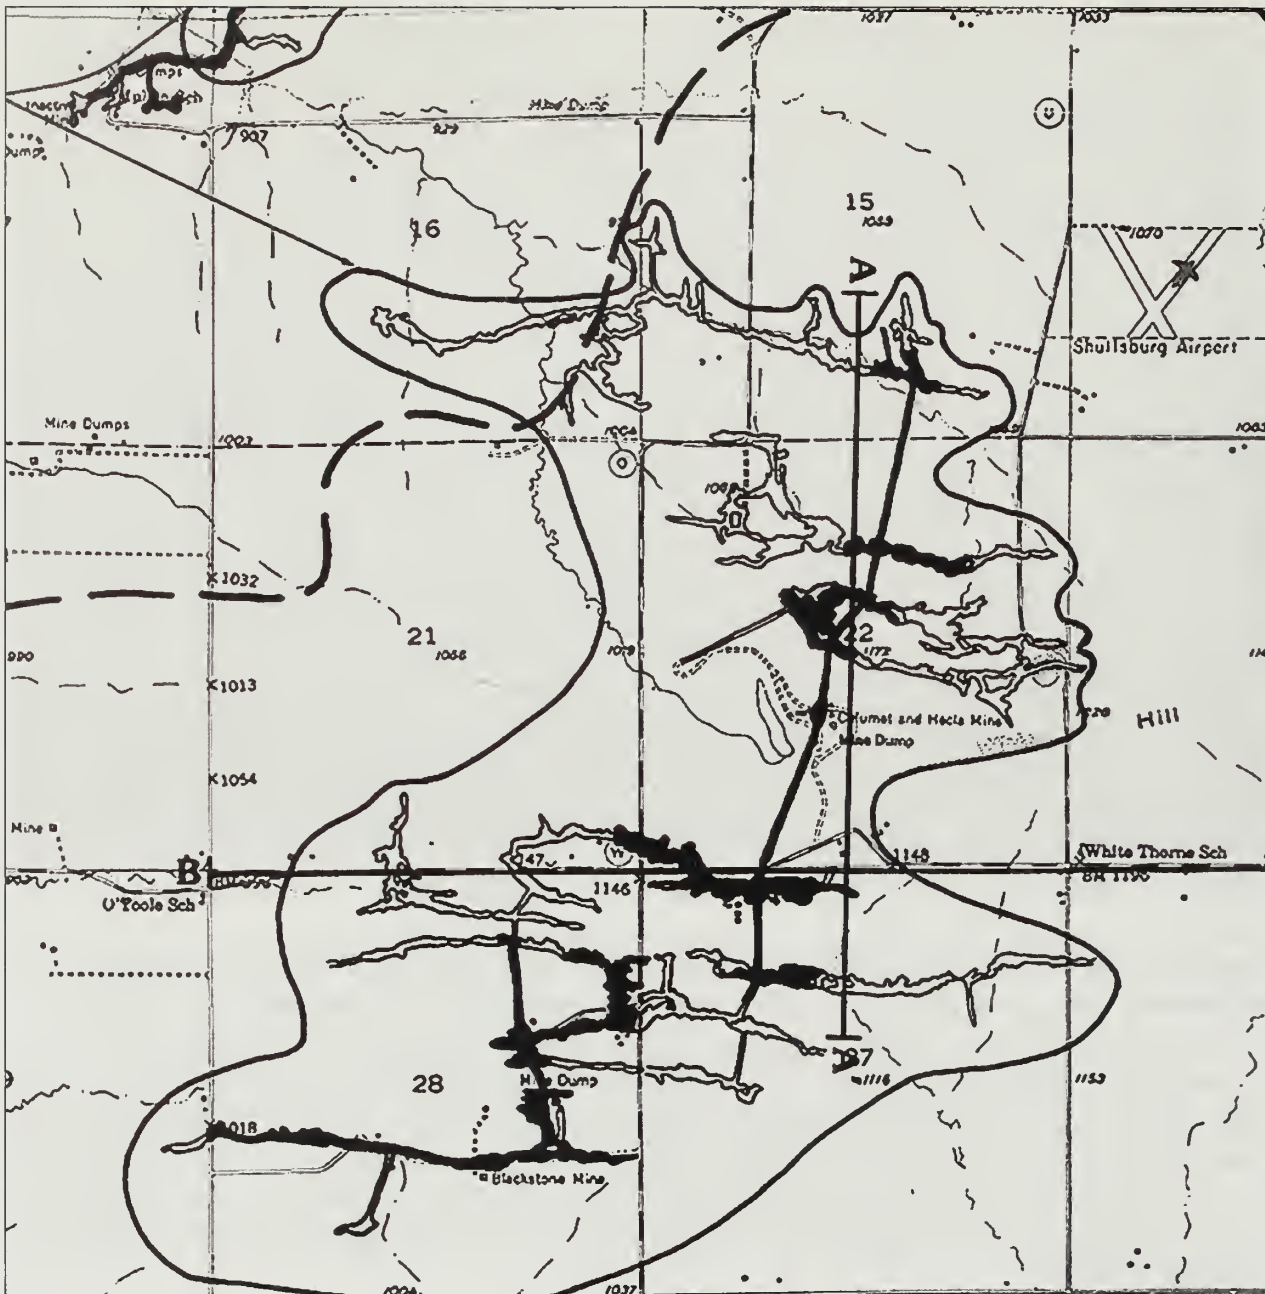
**Figure 6** Area of drawdown (cone of depression) caused by dewatering the Shullsburg mine complex.

The Shullsburg mine complex, which is located approximately 3 miles south of Shullsburg, was discovered by Calumet and Hecla Consolidated Copper Company in about 1947. In 1949, the company sunk a 360-foot shaft and began mining several underground ore bodies connected to the hoisting shaft by a series of drifts. The underground workings were extensive and ultimately connected to the Blackstone mine located to the southwest. The ore was processed by an on-site flotation mill (Figure 5). The mill feed ranged between 4 to 6% zinc, primarily as sphalerite. Mining was done below the water table, and a pumping rate ranging from 4 to 17 million gpd was required to dewater the mine workings. During the operating history of the Shullsburg complex, this dewatering created a cone of depression that extended over 12 square miles (Figure 6).

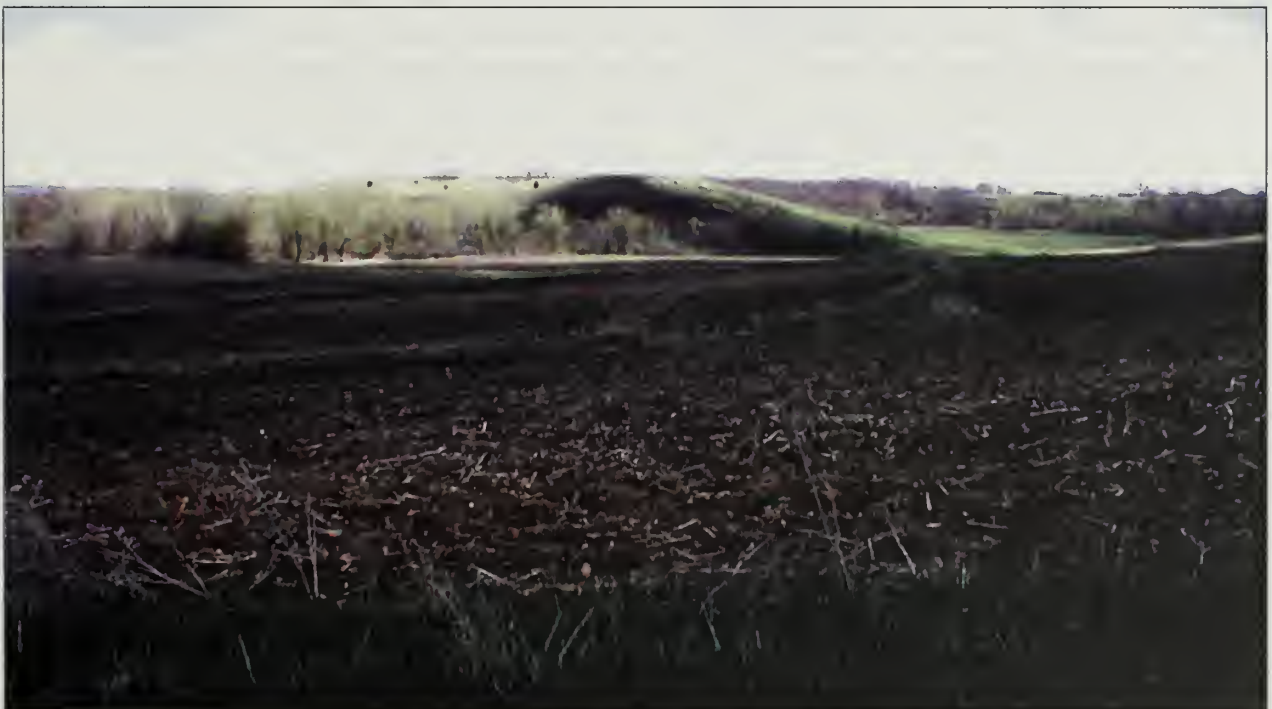
**Figure 7** View of Shullsburg mine site after reclamation circa 2007.

The existing vegetation on most former mine sites is introduced agronomic pasture grasses, although existing oak groves at some sites represent a snapshot of pre-settlement vegetation. Pasture grasses and legumes were approved and planted as reclamation species at most sites because the approved post-mining land use was pasture, a use that blends well with the adjacent land use patterns. However, the Shullsburg mining site was designated as wildlife habitat area, a use also compatible with the adjacent land use pattern. Where the land use is recreation or wildlife, such as at the Shullsburg site, native tree and grass species were required in the reclamation plan (Figure 7).

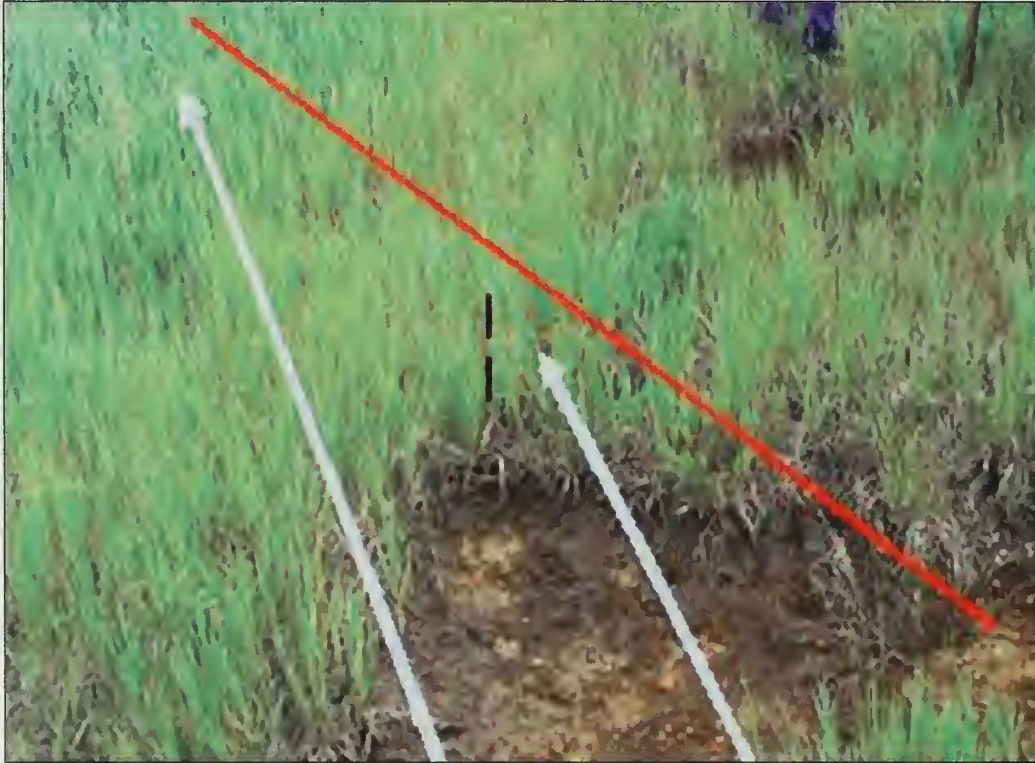
**Figure 8** Photograph illustrating the red spot problem. The red spots increase in size rather than filling in. Degradation of the vegetation compromises the integrity and stability of the tailings pile. The stress gradient on the vegetation is highlighted by the arrows: the left arrow shows tall robust vegetation; the middle shows thinning, weakened grasses; and the red arrow illustrates the gradient between healthy vegetation and the barren red spot. Photograph by Tom Portle, Wisconsin Department of Natural Resources.

**2008** – Aggressive research to solve red spot problem was initiated (Figure 8).

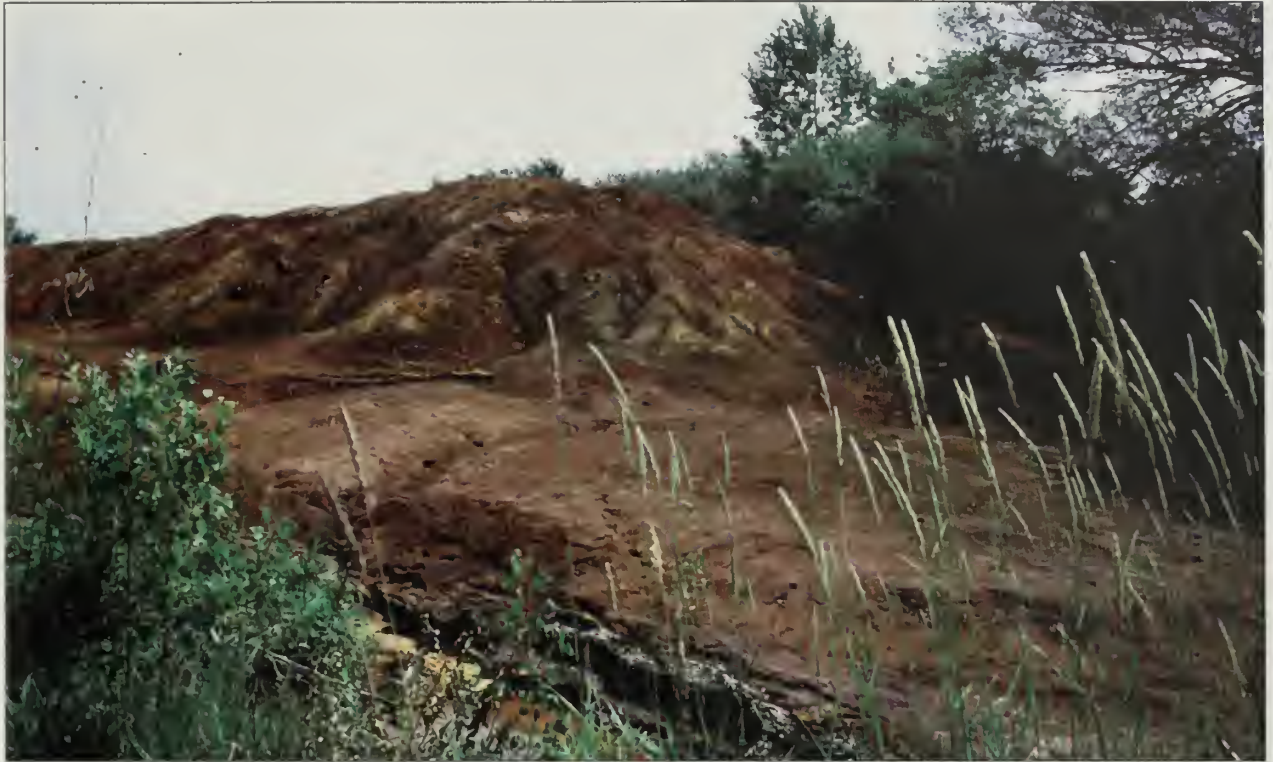
*Figure 9* Main zinc roaster waste pile at Mineral Point before reclamation circa 1980.

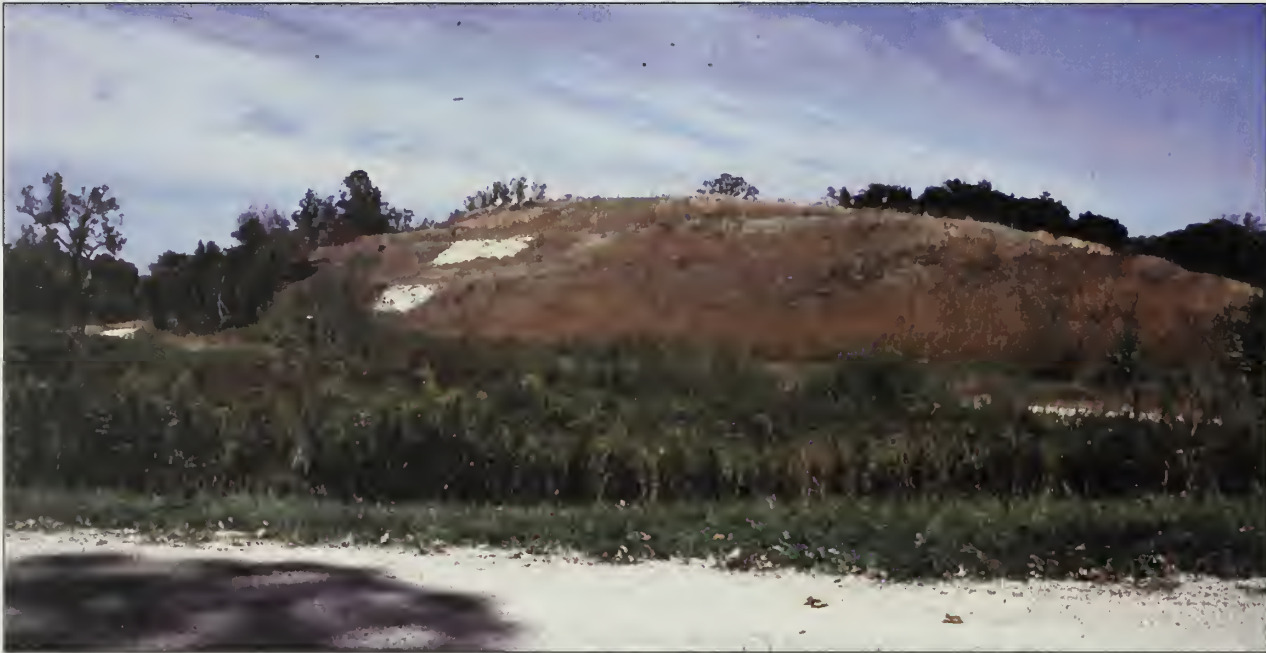
**Figure 10** View of the Mineral Point roaster waste after reclamation circa 2004.

A WDNR Environmental Repair Fund project to combine and cap the roaster piles began in early 1992 and was completed during fall 1993. Waste from several small piles was combined into the largest roaster pile located at the south edge of Mineral Point.

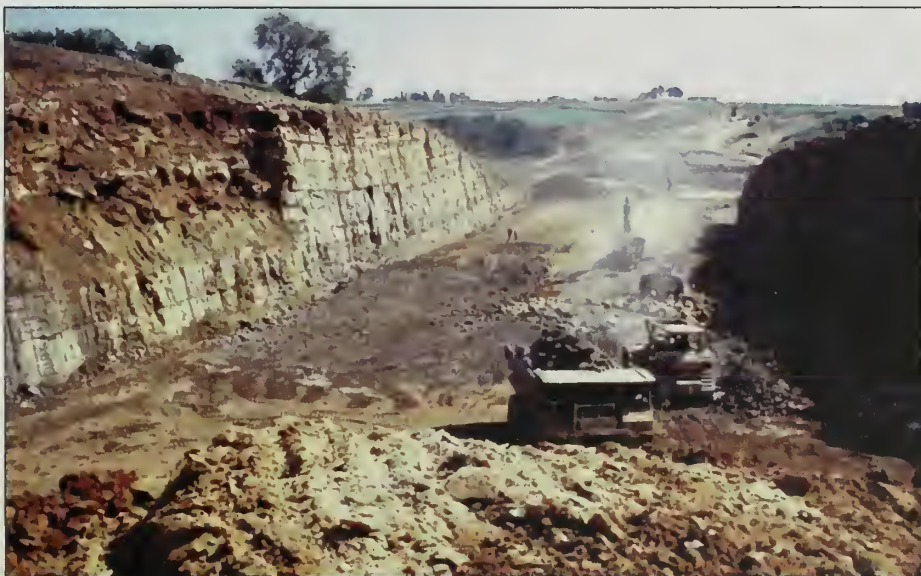
**Figure 11** U.S. Highway 151 fairgrounds road cut under construction in 2001.

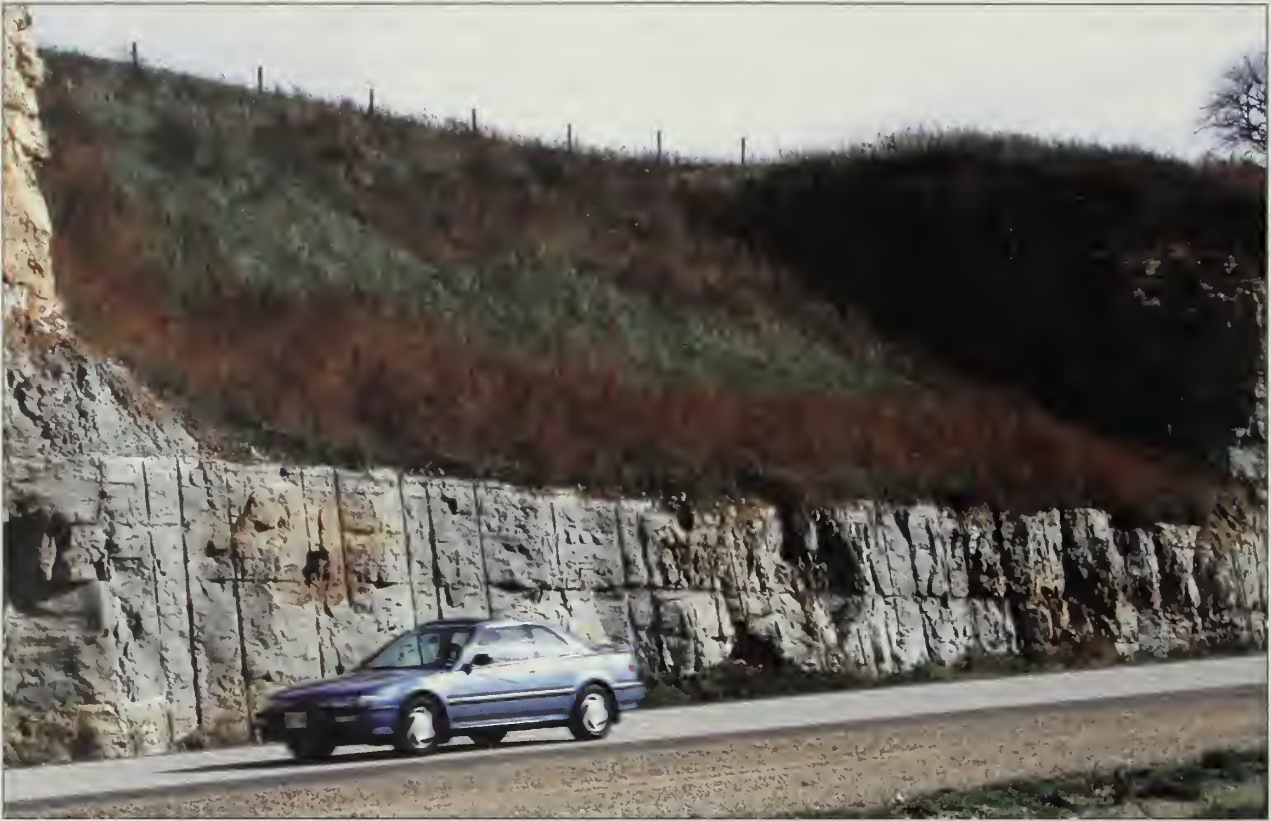
**Figure 12** Fairgrounds cut after modification circa 2003.

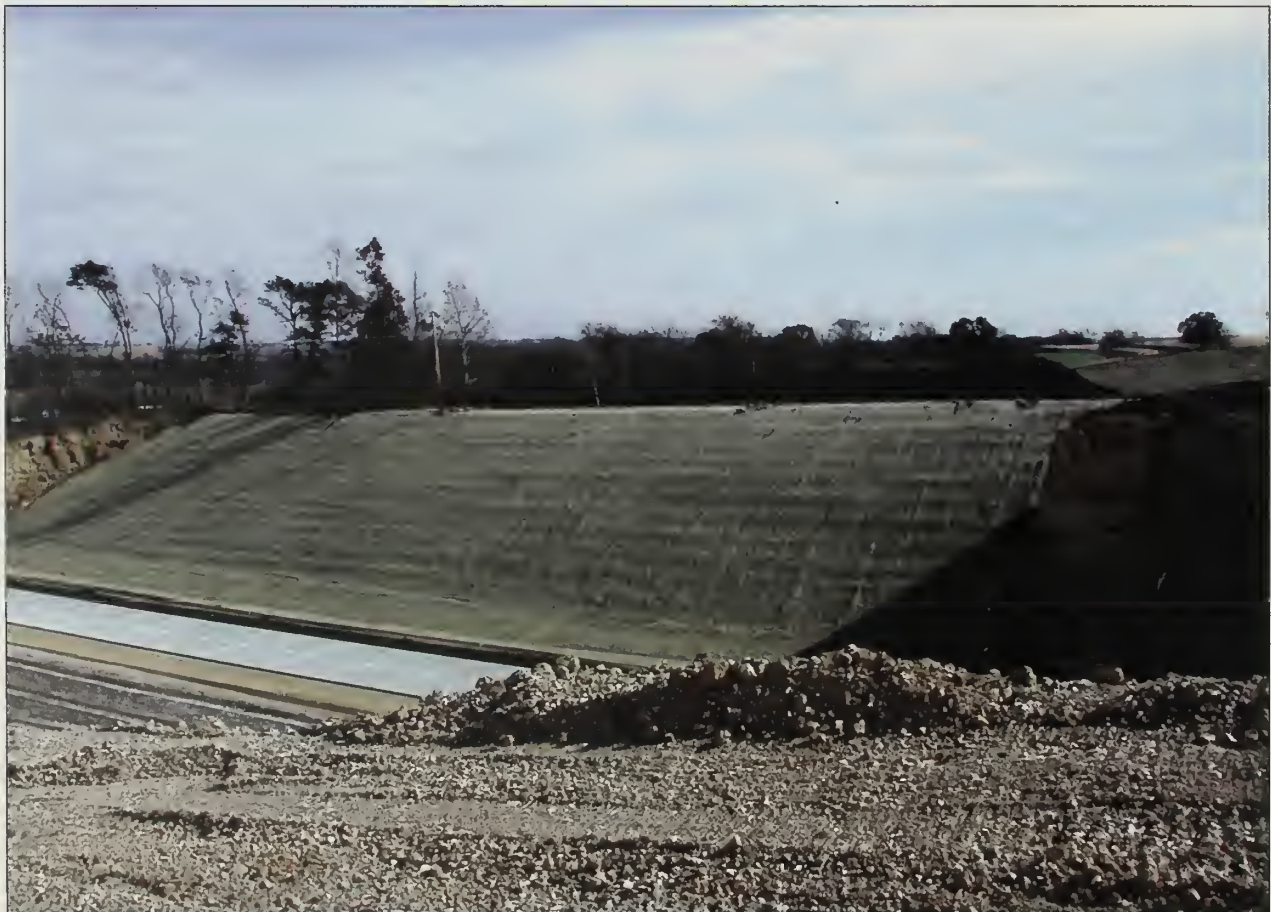
**Figure 13** U.S. Highway 151, County A cut circa 2003.

Another area of mineralization indicated by lead digs and a small zinc prospect was identified at the junction of U.S. 151 and County A near the Lafayette County line. This cut was redesigned with a cutback vegetated slope to avoid the problems at the fairgrounds cut (Figure 13), and it has performed well since. The modified design was incorporated prior to bidding the contract and saved the taxpayers the cost of remediation. No significant mining or mineralization problems were encountered south of County A.
